Understanding the Hazard

Exterior Wall Assemblies

Exterior wall assemblies are subject to damage from wind pressure, impact from windborne debris, and hail and leakage at penetrations of the protective weather coating. Exterior walls that contain combustible components also can present a fire hazard.

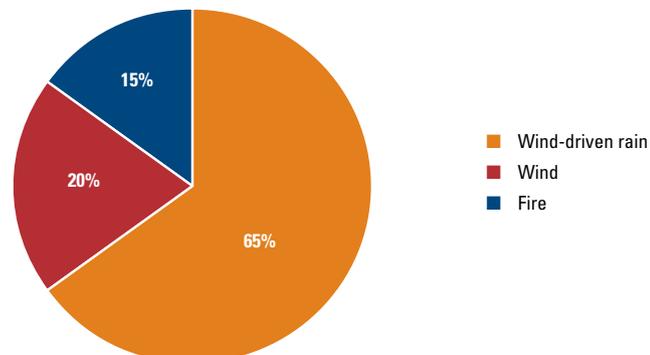
Losses by Cause (percentage of cost)

A study of FM Global client losses involving EIFS construction over a recent 10-year period shows the most significant causes (based on cost) were wind-driven rain, wind damage and fire.

Source: FM Global clients

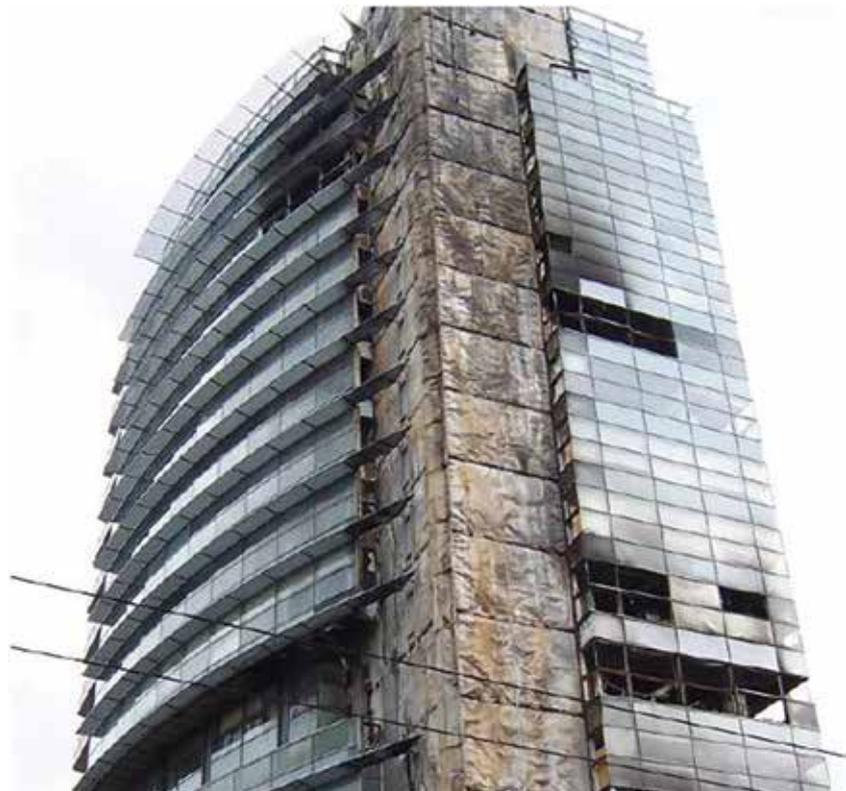
Combustible wall construction allowed fire to spread up the corner of this building.
